**WEBER HILL TERRACE LAKE DAM
JEFFERSON COUNTY, MISSOURI
MO 30449**

PHASE 1 INSPECTION REPORT NATIONAL DAM SAFETY PROGRAM

Name of Dam: Weber Hill Terrace Lake Dam
State Located: Missouri
County Located: Jefferson
Stream: Bear Creek
Date of Inspection: 19 July 1978

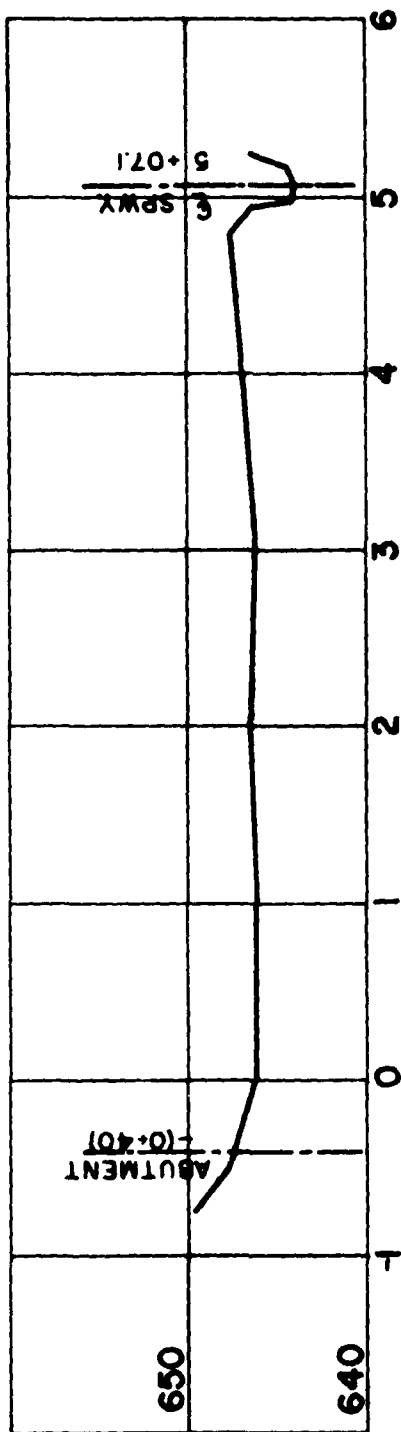
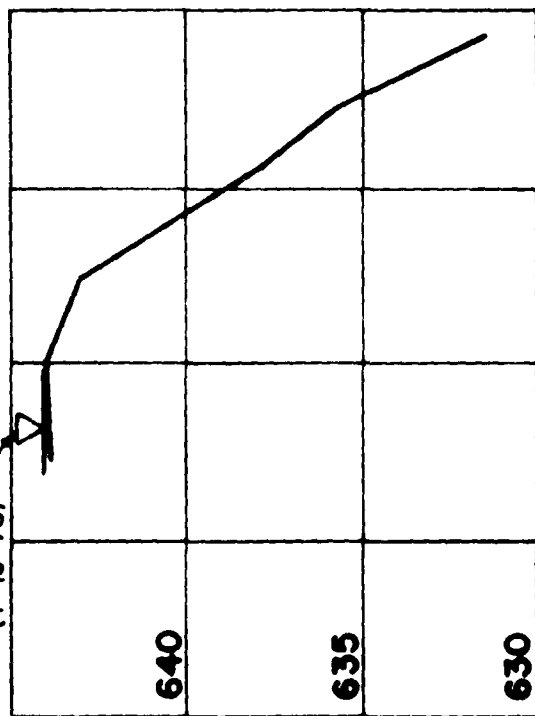
WEBER HILL TERRACE LAKE
 DAM & SPILLWAY PROFILES
 Horner & Shiffrin, Inc. July 1978

The elevation of the top of the dam, as determined by survey, was found to be from 1.0 to 1.3 feet lower across the central area of the dam than the top of dam in the area adjacent to the spillway. A profile of the dam crest centerline extending through the spillway section is shown on Plate 3.
